INSPECTION REPORT  
OF THE  
**CITY OF JACKSON – MADDOX ROAD PUBLIC WATER SYSTEM**  
**JACKSON, MISSISSIPPI**

By  
**U.S. ENVIRONMENTAL PROTECTION AGENCY**  
**REGION 4**  
**ENFORCEMENT AND COMPLIANCE ASSURANCE DIVISION**  
**WATER ENFORCEMENT BRANCH**  
**DRINKING WATER ENFORCEMENT SECTION**

July 29, 2022

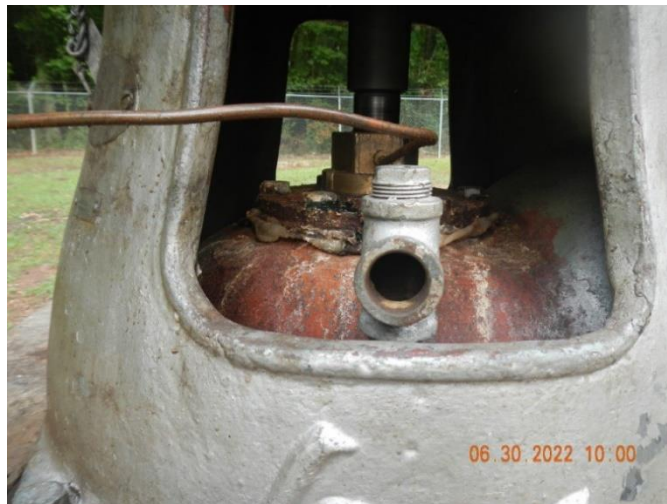
2. **Finding:** EPA inspectors found that the following wells were missing well vent screens: TV Road Well (Photograph 1), Highway 18 Well (Photograph 2), Willowood Well (Photograph 3), and Siwell Well (Photograph 4).

**Comment:** The screen prevents insects and other organisms from entering the well. Insects and other organisms are possible vectors for disease and contamination. Following the inspection, COJ staff provided documentation that screens were installed on the TV Road and Willowood well vents (Photograph 5 and 6).

**Photograph 1:** TV road well vent

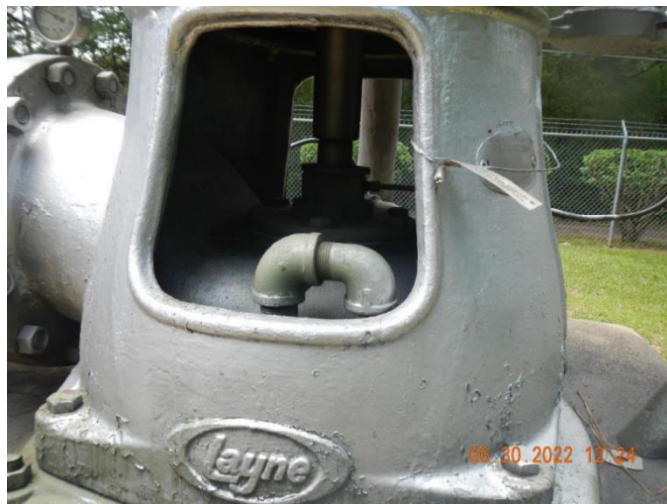
**Photograph 2:** Highway 18 well vent

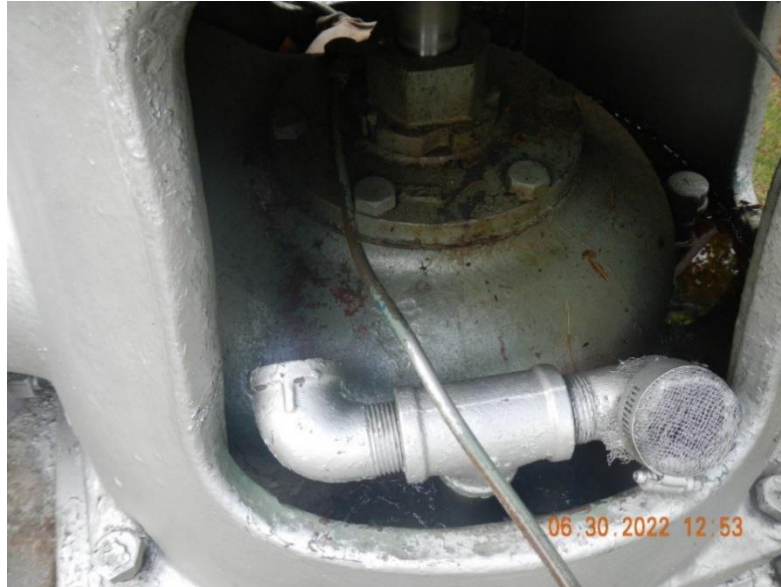
**Photograph 3:** Willowood well vent

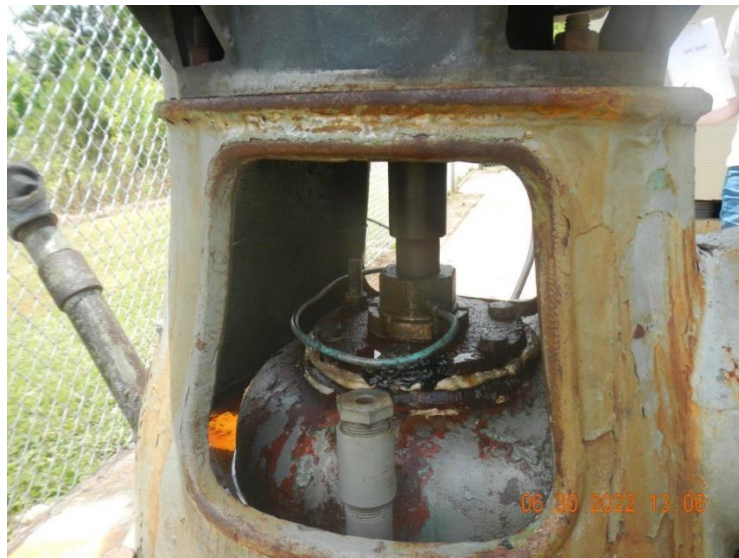
**Photograph 4:** Siwell well vent

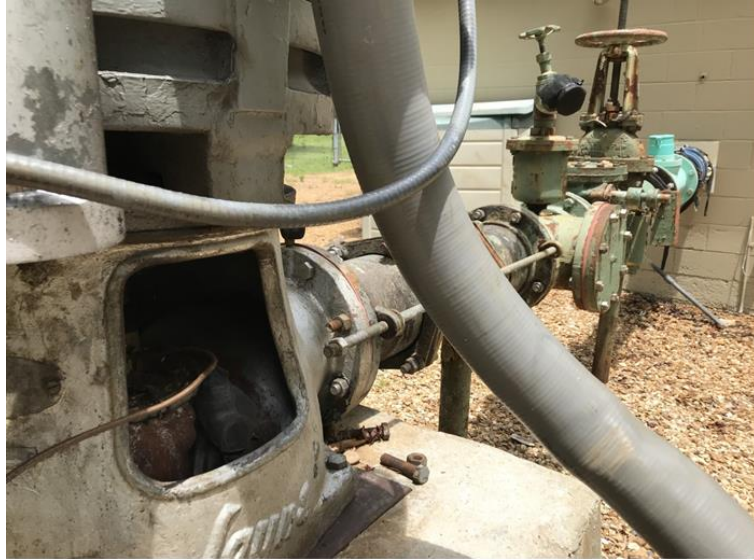
**Photograph 5:** Screened TV road well vent and air release

3. **Finding:** The TV Road well was observed to be missing an air relief screen (Photograph 7).  
**Comment:** Following the inspection, COJ staff provided documentation that screens were installed on the TV Road well (Photograph 5).
4. **Finding:** Inspectors observed the ladder of the Spring Ridge tank without appropriate security to prevent trespassing and access to the top of the tank (Photograph 8).

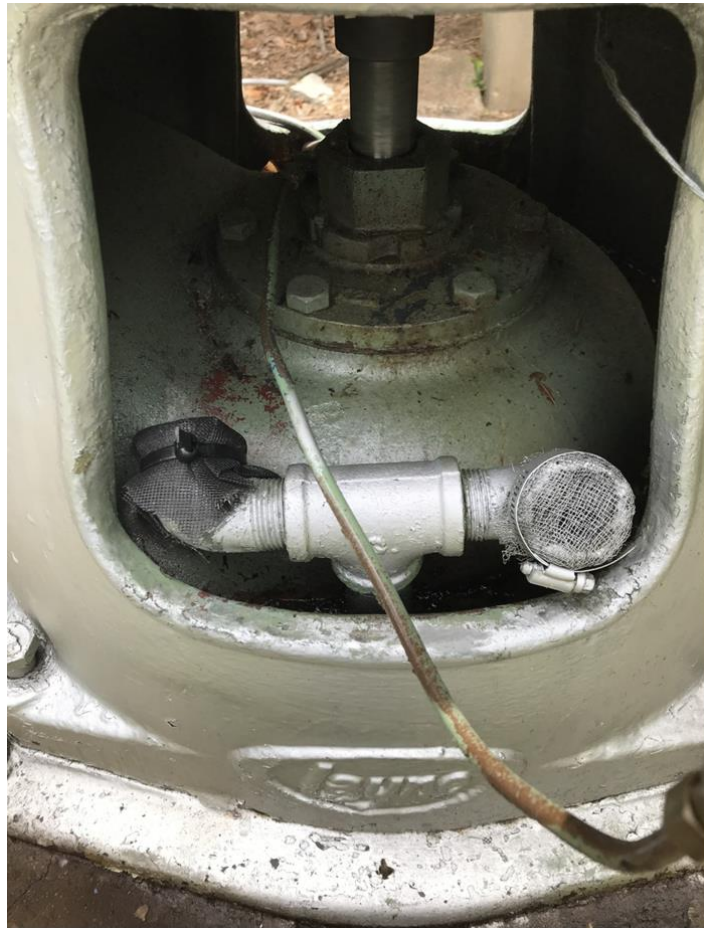
**Photograph 6:** Screened Willowood well vents

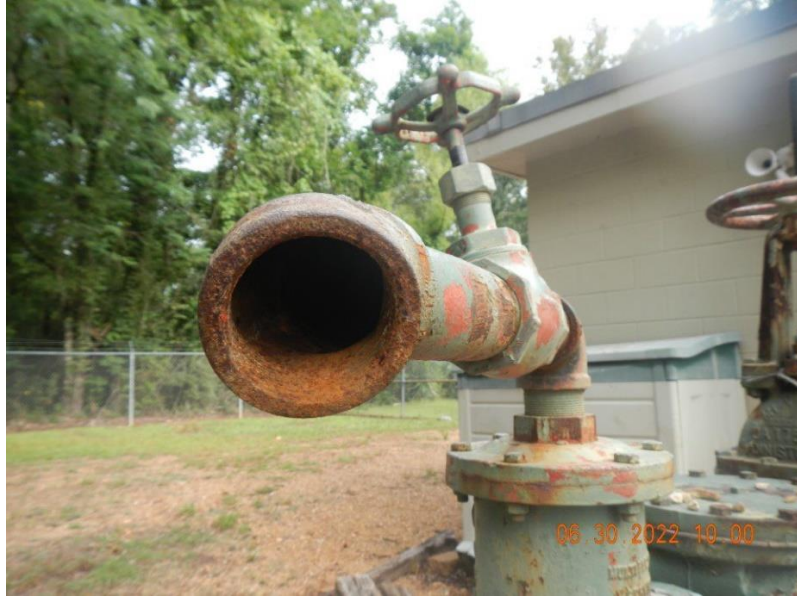
**Photograph 7:** Tv road unscreened air relief

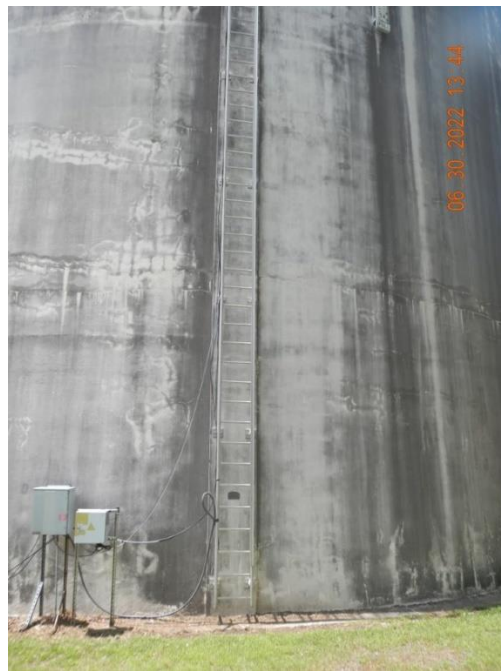
**Comments:** Access to storage tank ladders needs to be limited to water treatment personnel to prevent unauthorized access into the finished water storage.

**Photograph 8:** Missing ladder cover at Spring Ridge tank

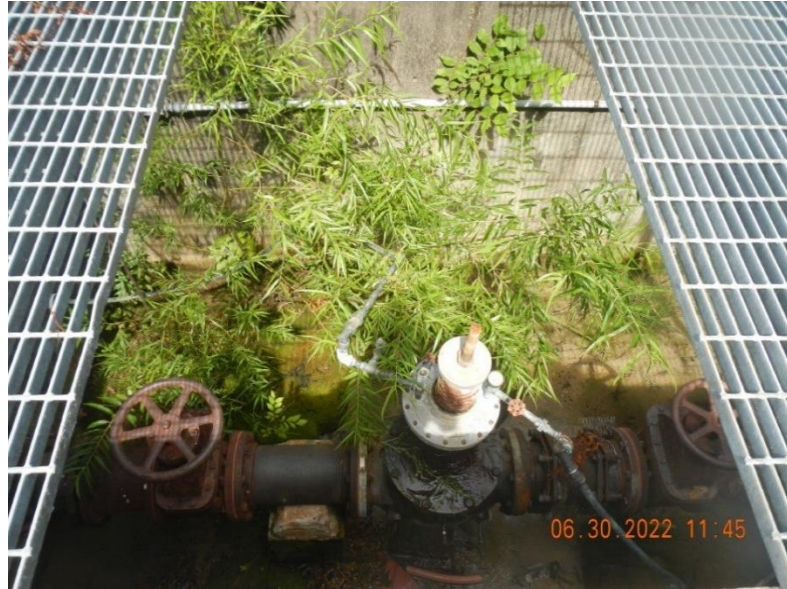
4. **Observation:** Vegetative growth in the valve box was observed at the Cedar Hills tank (Photograph 9).

**Comment:** It is best practice to keep vegetation growth off water system components to prevent unnecessary wear and tear on the assets. Excessive vegetation can both damage and prevent use of the valves located in the valve box.

**Photograph 9:** Vegetation in valve box at Cedar Hills tank

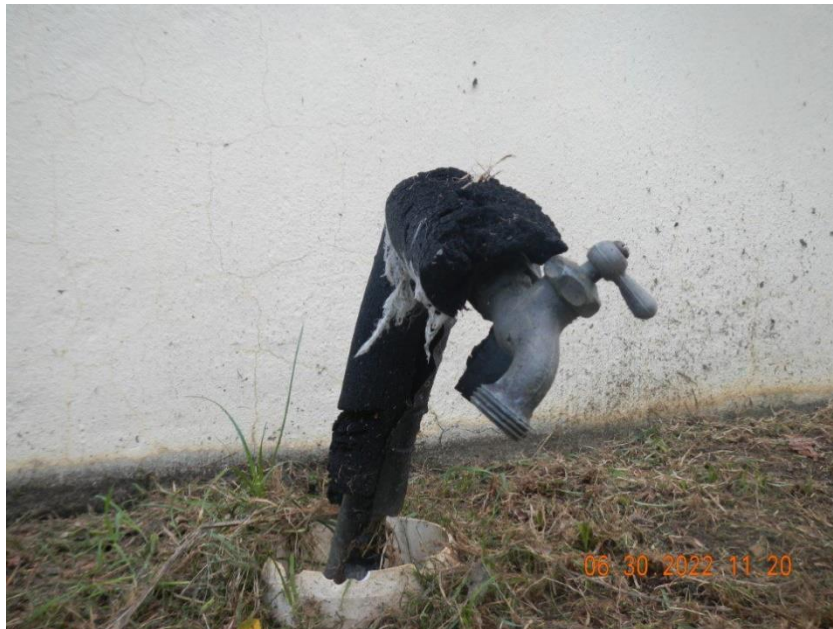
5. **Observation:** Threaded hose-bib sample taps were observed next to the Highway 18 (Photograph 10) and Spring Ridge tanks (Photograph 11).

**Comment:** A threaded hose-bib connected to the water tank provides a potential for a cross-connection. In the event of a cross-connection, significant loss of pressure in the system would allow for contaminants to enter the finished water storage tank. Cross-connections are prohibited in accordance with *Miss. Cod Ann . §41-26-14* and *MPDWRs Rule 1.8.1*.

**Photograph 10:** Threaded hose tap at Highway 18 tank

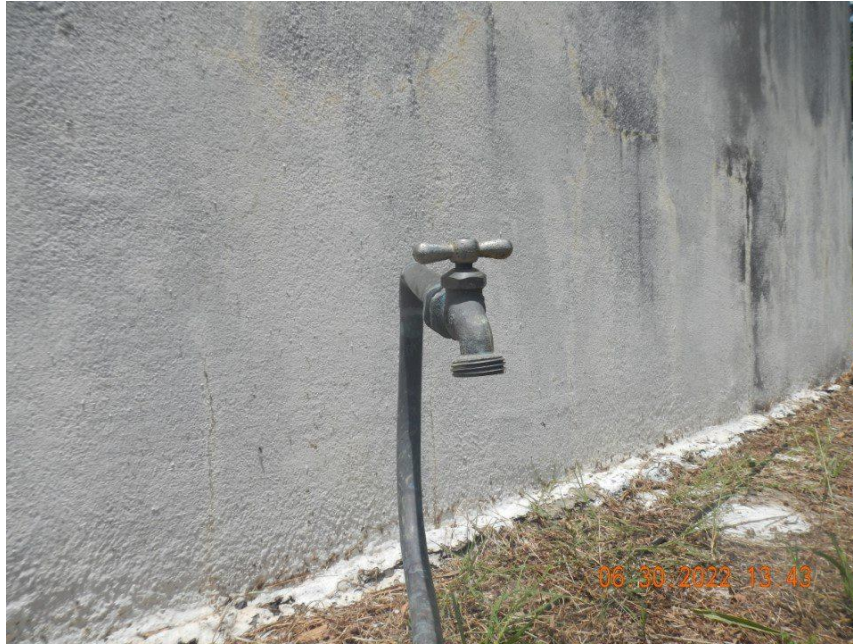
**Photograph 11:** Threaded tap at Spring Ridge tank

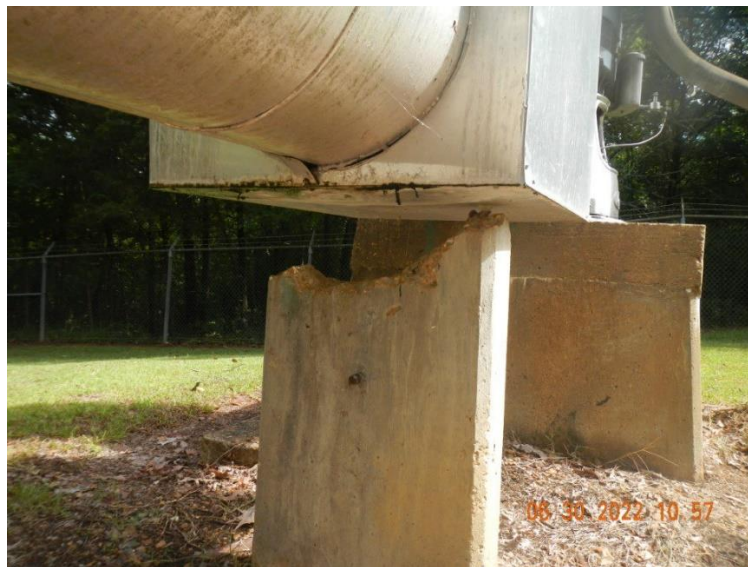
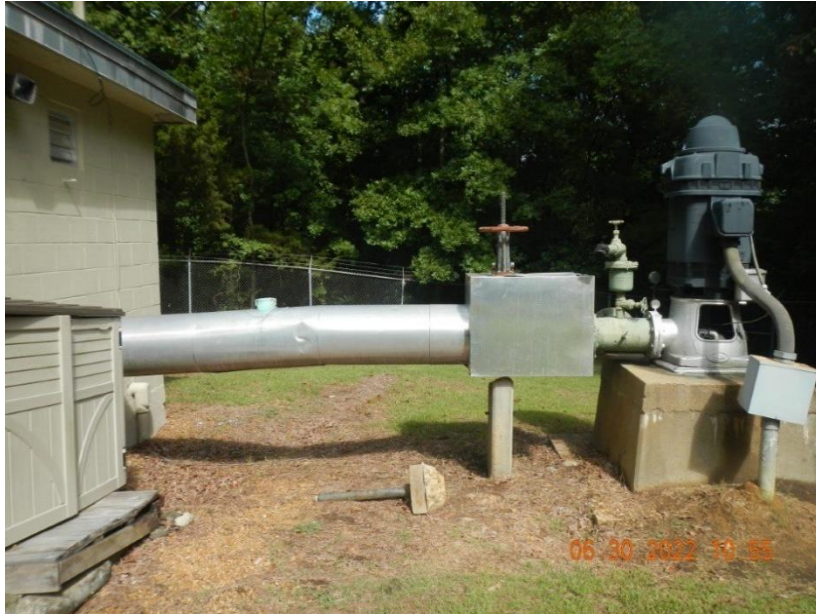
6. **Observation:** The pipe support underneath the Wiggins well was not connected to the pipe (Photographs 12 and 13).

**Comment:** Proper support of well pipes is important to maximize the longevity of the pipe.

**Photograph 12:** Detached pipe support

**Photograph 13:** Detached pipe support

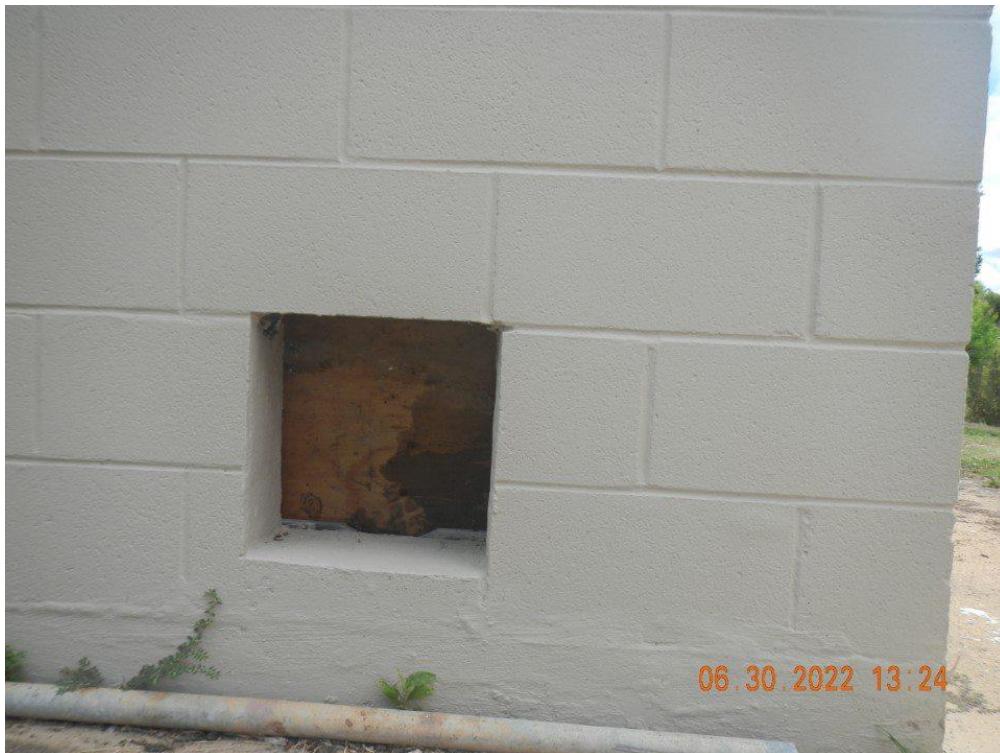
7. **Observation:** The vent hole for the fluoride room was covered at the Siwell well house (Photograph 14).

**Comment:** Proper ventilation is important for operator safety by preventing a buildup of harmful fumes in chemical rooms.

**Photograph 14:** Covered ventilation at Siwell wellhouse

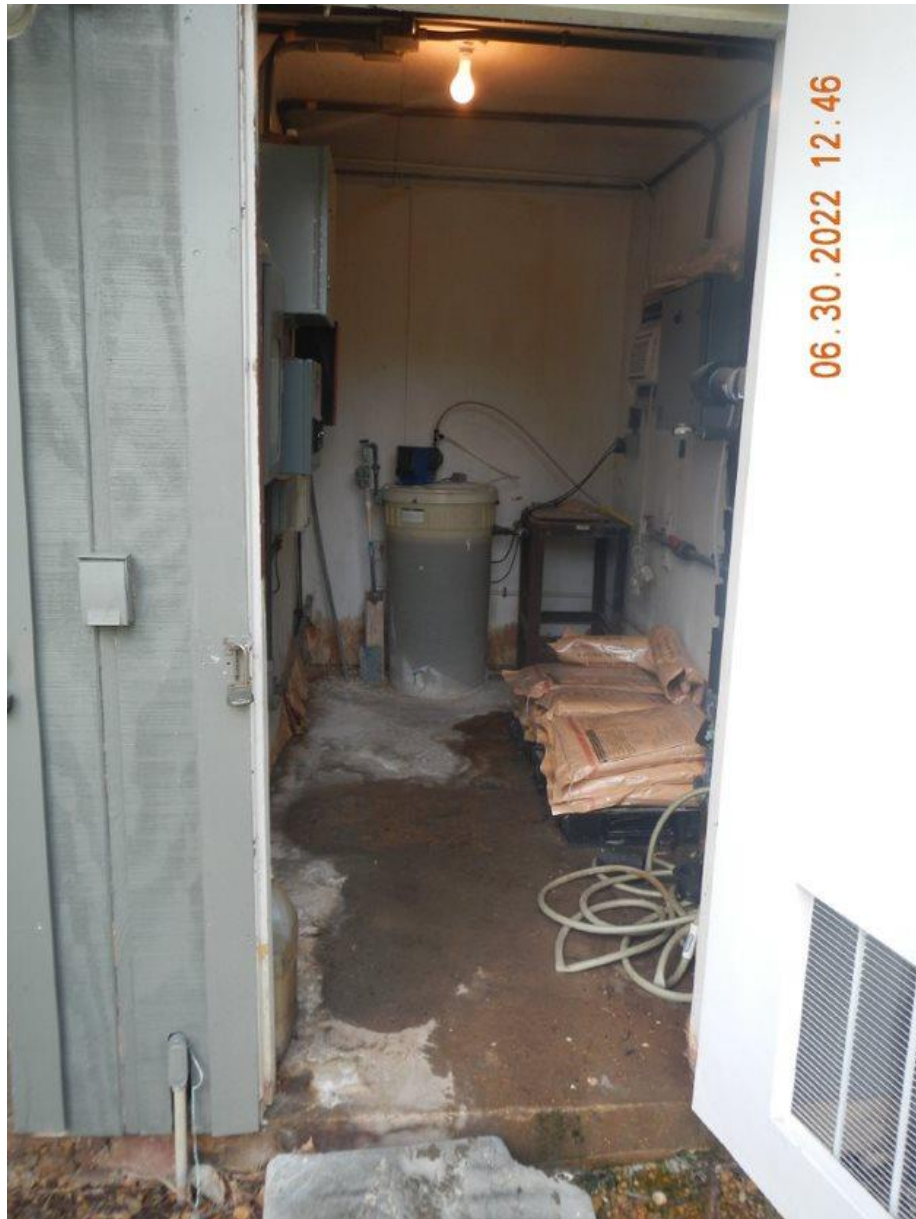
8. **Observation:** Fluoride drums were not observed to be double barreled and in the event of a spill, drain straight into the storm drain (Photograph 15).

**Comment:** Chemical containment will prevent the release of fluoride into the sewer drain.

**Photograph 15:** Fluoride drum in Willowood wellhouse

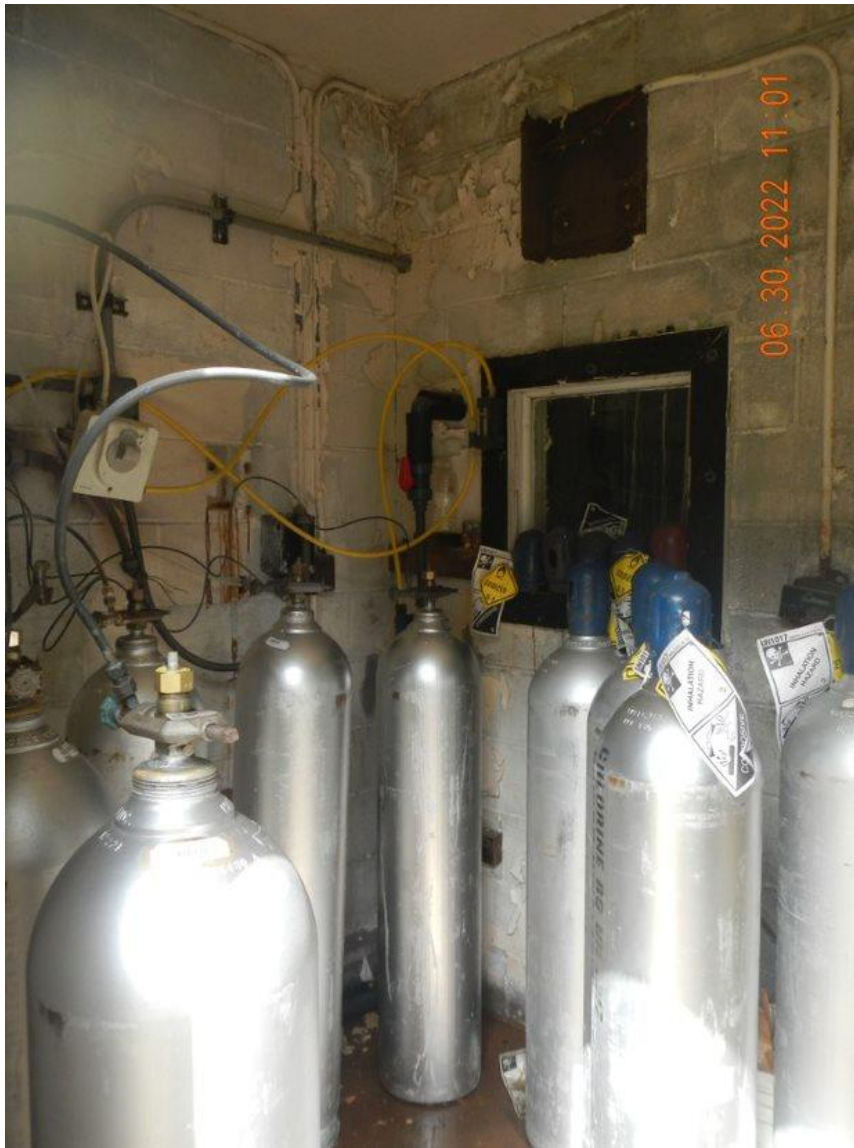
10. **Observation:** The interior of the well houses showed signs of degradation and lack of maintenance (peeling paint, disintegrating wood, caving in of ceilings, piling of ant beds under doorway). (Photographs 14 and 15).

**Comment:** Interior of the well houses should be kept in good condition to preserve the integrity of the building. The well house provides security to water treatment and water system assets.

**Photograph 16:** Building degradation inside Wiggins wellhouse
